## **Vegetation and Channel Morphology Responses to Ordinary High Water Discharge Events in Arid West Stream Channels**

Robert Lichvar, David Cate, Corinna Photos,  
Lindsey Dixon, Bruce Allen, and Joel Byersdorfer

May 2009

*Cold Regions Research and Engineering Laboratory  
U.S. Army Engineer Research and Development Center  
72 Lyme Road  
Hanover, NH 03755-1290*

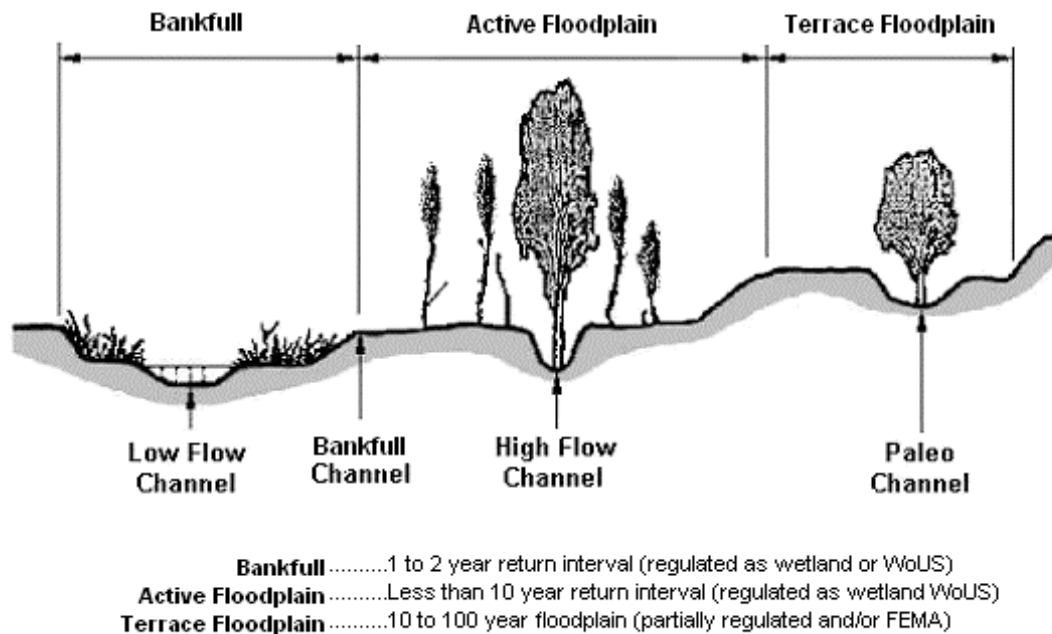
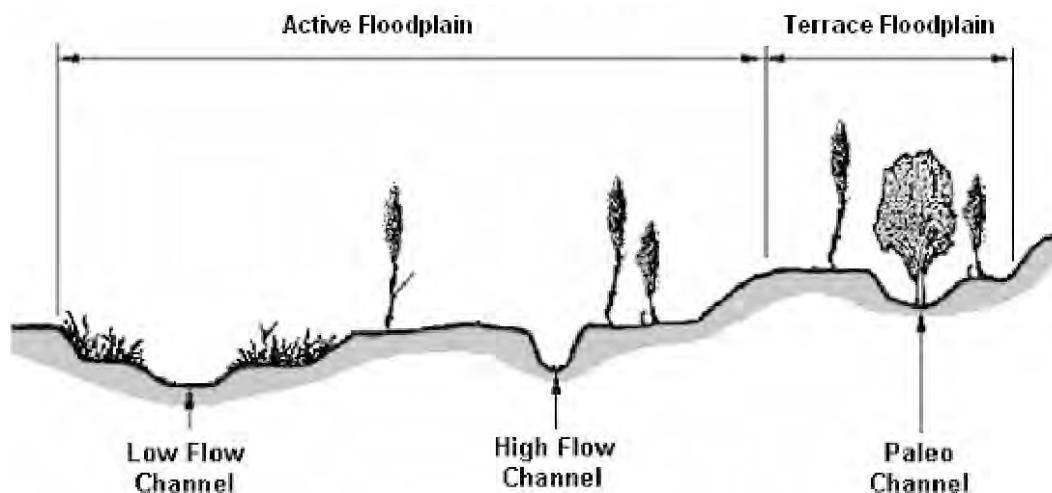
a. Perennial channel forms.

b. Intermittent and ephemeral channel forms.

Figure 1. Typical cross section depicting hydrogeomorphic floodplain units for typical streams.

Channel morphology is influenced by the hydrologic regime and by the tendency of the channel to establish a state of equilibrium (Field and Lichvar 2007). These components drive the quantity of sediment deposited and eroded in the channel, in turn influencing the geometry of the channel and the surrounding floodplain. Common fluvial features typical of the perennial channel and floodplain include a bankfull channel, the active floodplain, and the terrace floodplain (Figure 1).

In intermittent and ephemeral streams, low-flow channels in the active floodplain differ from the bankfull channel of perennial streams. In the Arid West, the low-flow channel of an intermittent or ephemeral stream will form and relocate during low to moderate discharge events (5–10 years) instead of being maintained by continuous flows, as in perennial streams. This channel is unstable because flashy discharge events alter the hydrologic regime and because sedimentary deposits and erosional features throw the system into imbalance.

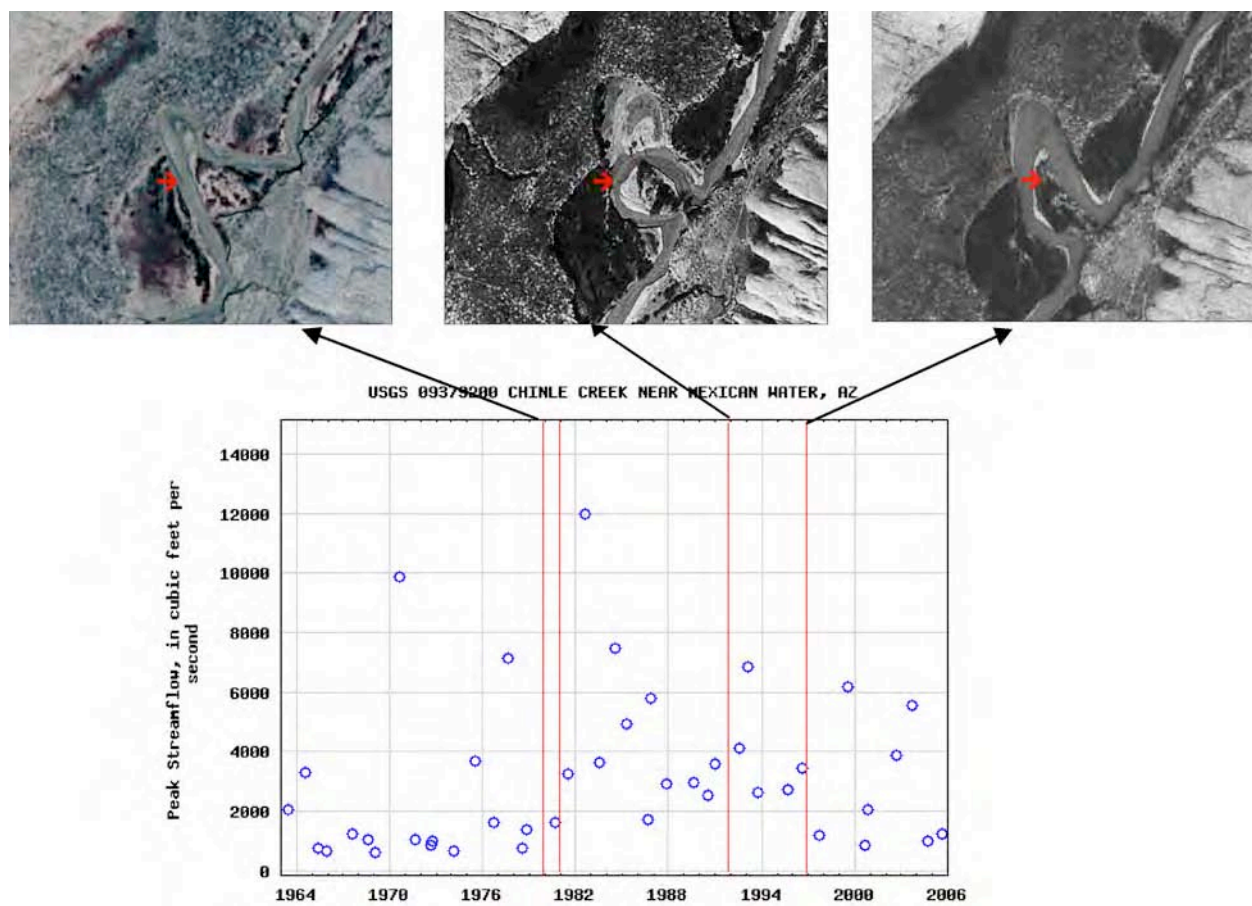
Figure 4. Chinle Creek near Mexican Water, AZ. The red arrow shows the shift in the channel from 1981, 1992, and 1997. The second two photos were used in this analysis.

To assess the impact of a discharge event on the eight chosen sites, we determined the change in the channel upstream from the stream gauge by viewing one aerial image prior to a discharge event and one aerial image after that discharge event (Figure 4). For each site, both before and after the flood event, riparian corridors were delineated for various channel features using the digital imagery within ArcView GIS (geographic information system) 3.2 and ArcMap 9.2. All mapping was done at a scale of 1:2,400 representative fraction. To better locate and identify surfaces, we used support spatial databases, including topography maps from the U.S. Geological Survey and contour lines that were created within ArcMap.

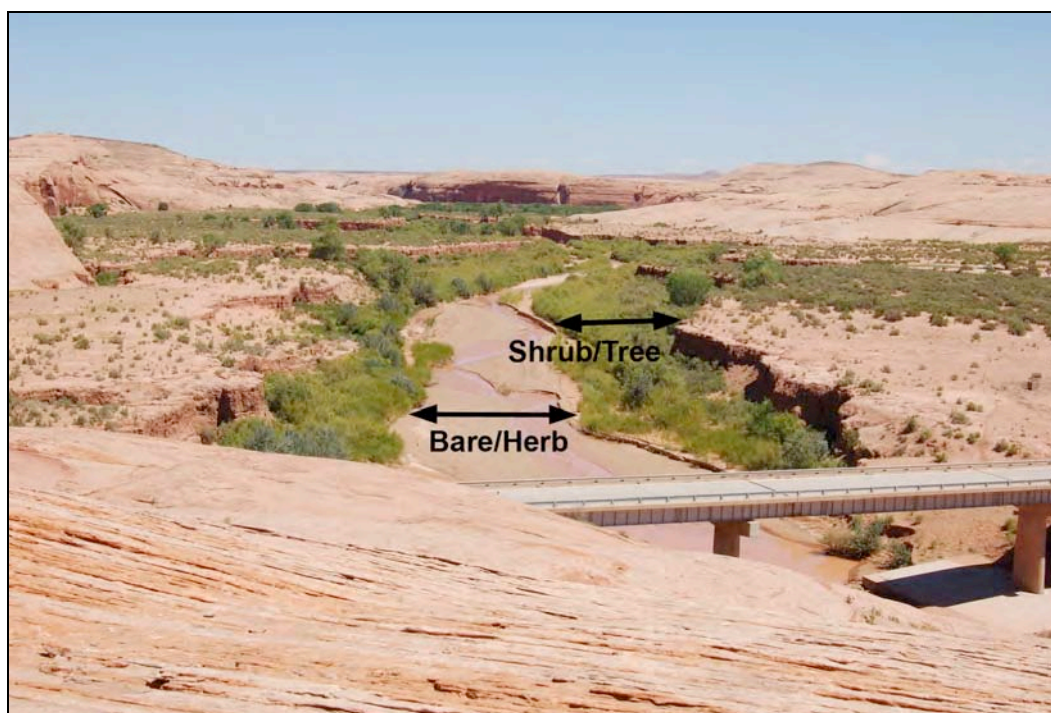
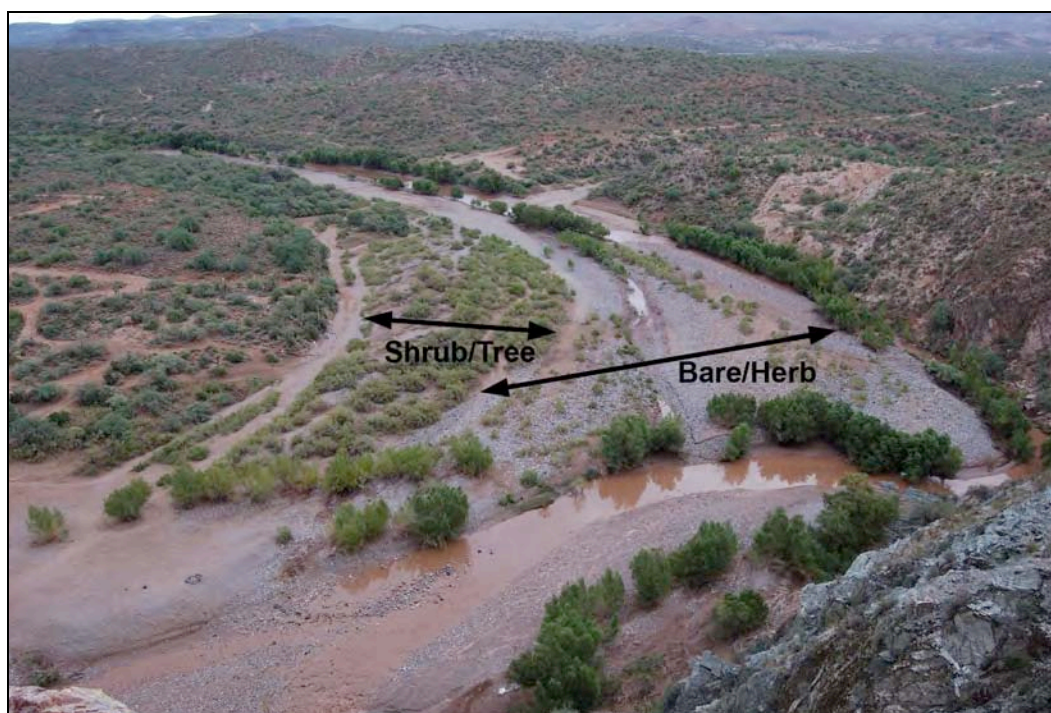
a. Chinle Creek

b. Agua Fria

Figure 5. Vegetation categories at two sites.

Once the hydrogeomorphic surfaces and vegetation boundaries were mapped, we calculated the areas for the bankfull channel and the active and terrace floodplains and for the vegetation within each of the hydrogeomorphic zones. From the areas occurring in each zone, we calculated percentages for each surface and vegetation type. We could then determine the changes in area between the two photos in each pair.

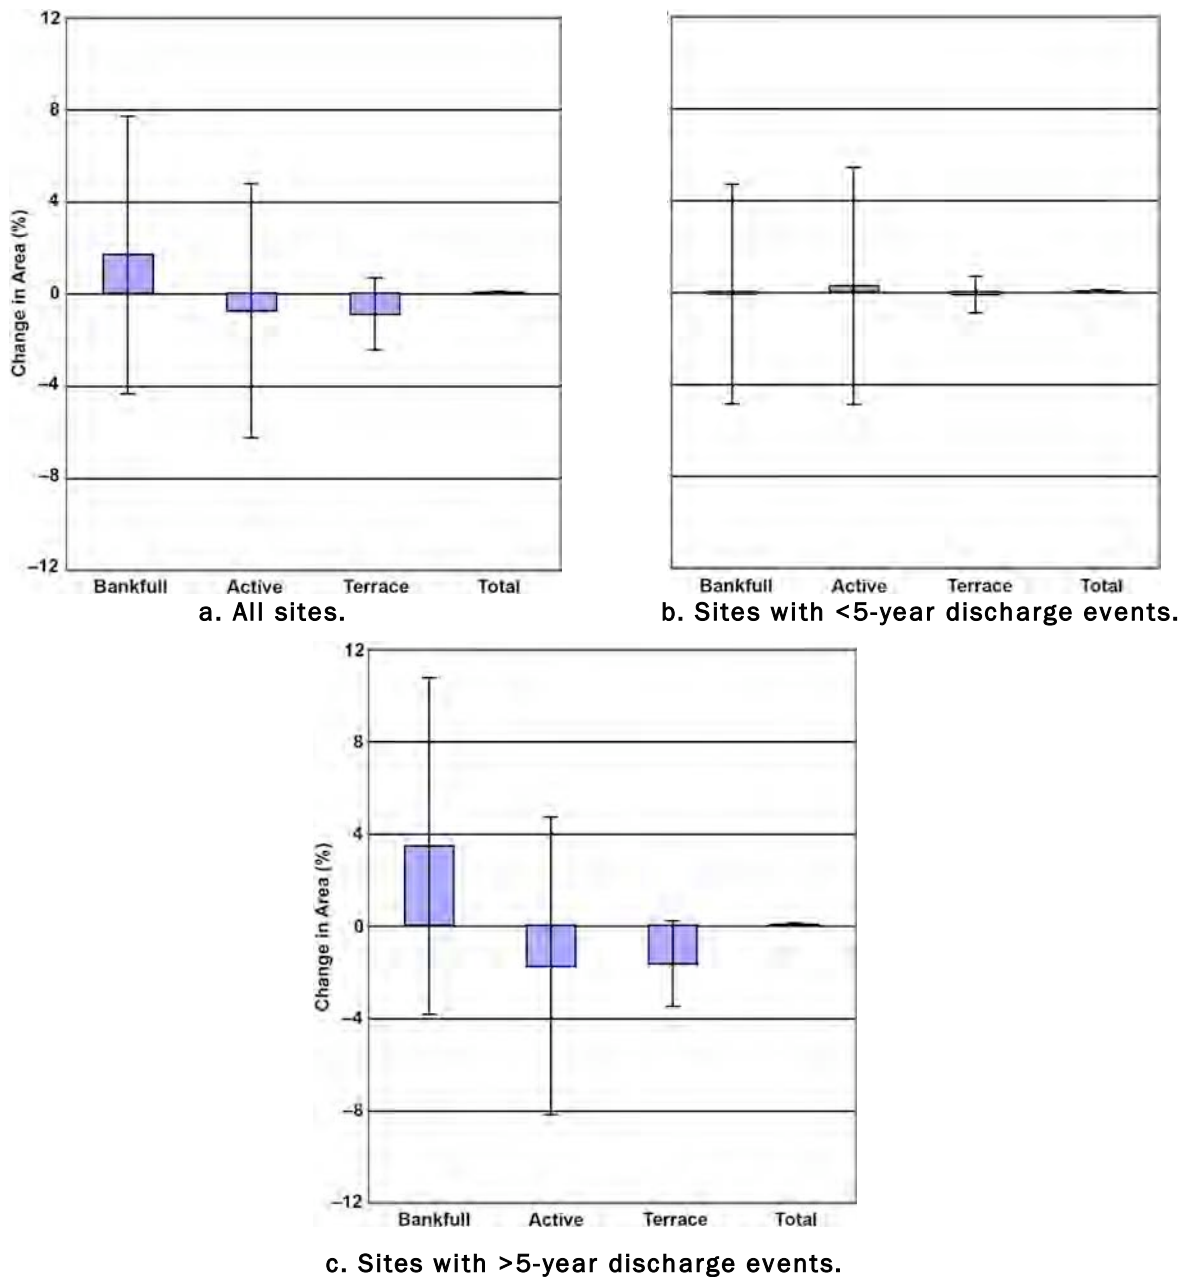
Figure 6. Mean changes in channel morphology zones ( $\pm$  one standard deviation).

The aerial photos and the hydrogeomorphic and vegetation delineations are shown in Appendix C. Appendix D contains the data extracted from the delineations. Figures 6 and 7 and Table 2 show summaries of the data for all sites, for sites with low-discharge events, and for sites with moderate-discharge events.

The amount of variability, as indicated by the size of the error bars in Figures 6 and 7, is consistent with our understanding of the dynamics of

ephemeral/intermittent channels in the Arid West. Figure 6 shows, for channel morphology, high variability for the area of the bankfull and active zones and low variability for the terrace. Since there was only one discharge event larger than 10 years, this is as expected; the events had little effect on the morphology of the terrace. For vegetation (Figure 7), the variability in the various categories was similar (except for shrub/tree in the bankfull zone, which makes sense because there were very few shrubs or trees in that zone).

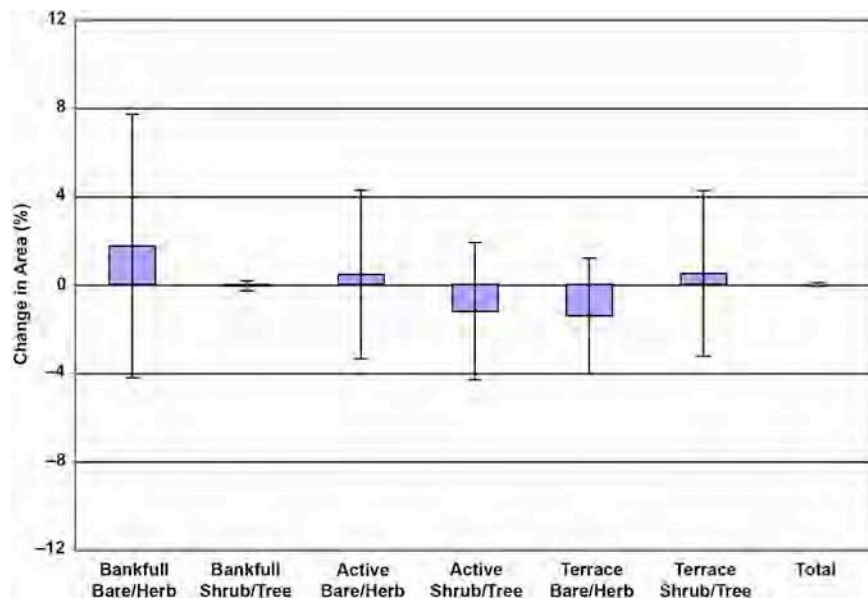
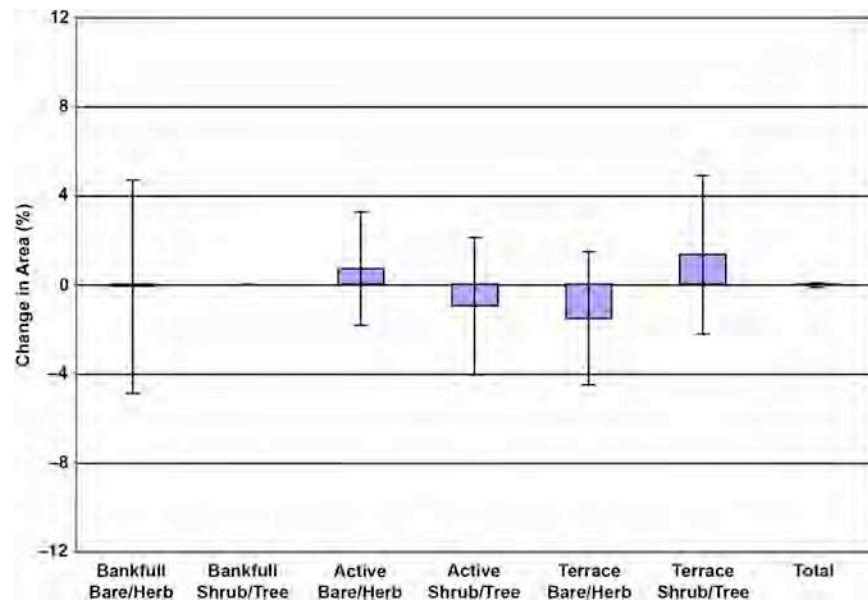
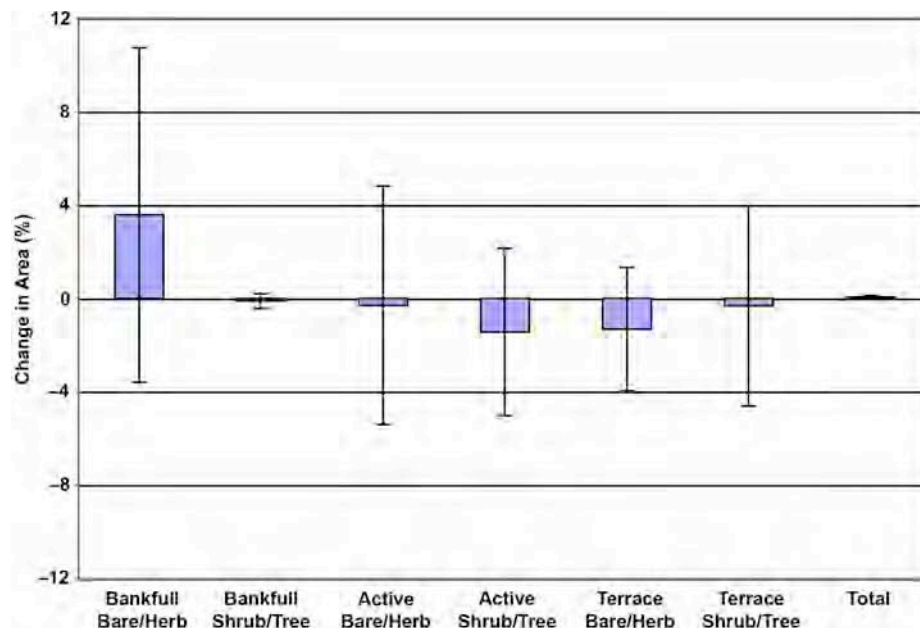
a. All sites.

b. Sites with &lt;5-year discharge events.

Figure 7. Mean changes in vegetation for all sites ( $\pm$  one standard deviation).

c. Sites with &gt;5-year discharge events.

Figure 7 (cont.) Mean changes in vegetation for all sites ( $\pm$  one standard deviation).

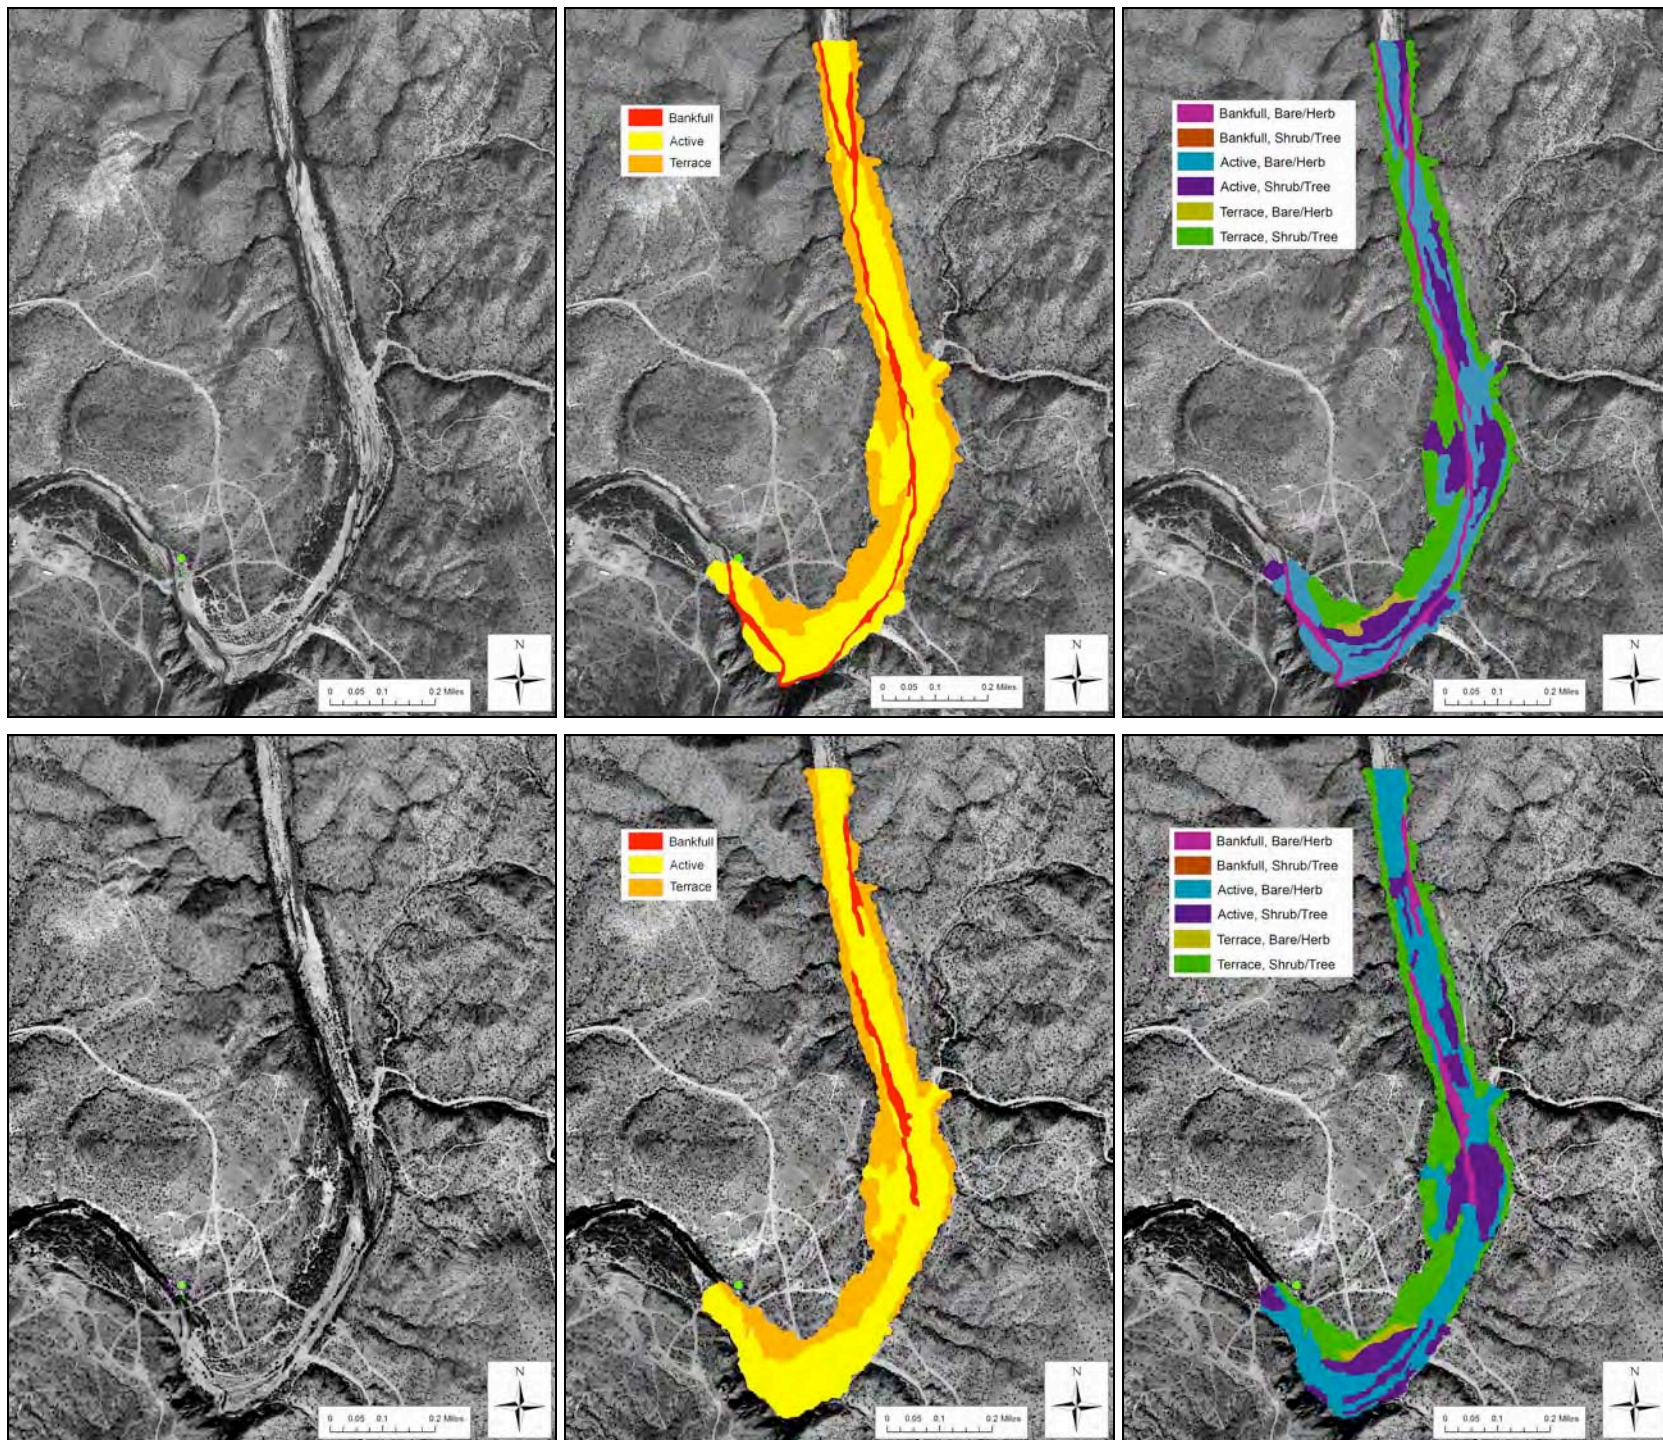
Figure C1. Agua Fria in 1997 (top three) and 2003 (bottom three) showing the change in channel morphology and vegetation.

1997		2003	
	Area (m <sup>2</sup> )	% of Total	Area (m <sup>2</sup> )	% of Total
Bankfull	40,036	10.1	22,484	5.5
Active	218,184	55.1	243,672	60.2
Terrace	137,861	34.8	139,801	34.4
Total	396,081	100	405,957	100.1
Bankfull-Bare/Herb	40,036	10.1	22,484	5.5
Bankfull-Shrub/Tree	0	0	0	0
Active-Bare/Herb	133,259	33.6	154,432	38.0
Active-Shrub/Tree	84,925	21.4	89,240	22.0
Terrace-Bare/Herb	5,816	1.5	5,038	1.2
Terrace-Shrub/Tree	132,045	33.3	134,763	33.2
Total	396,081	99.9	405,957	99.9

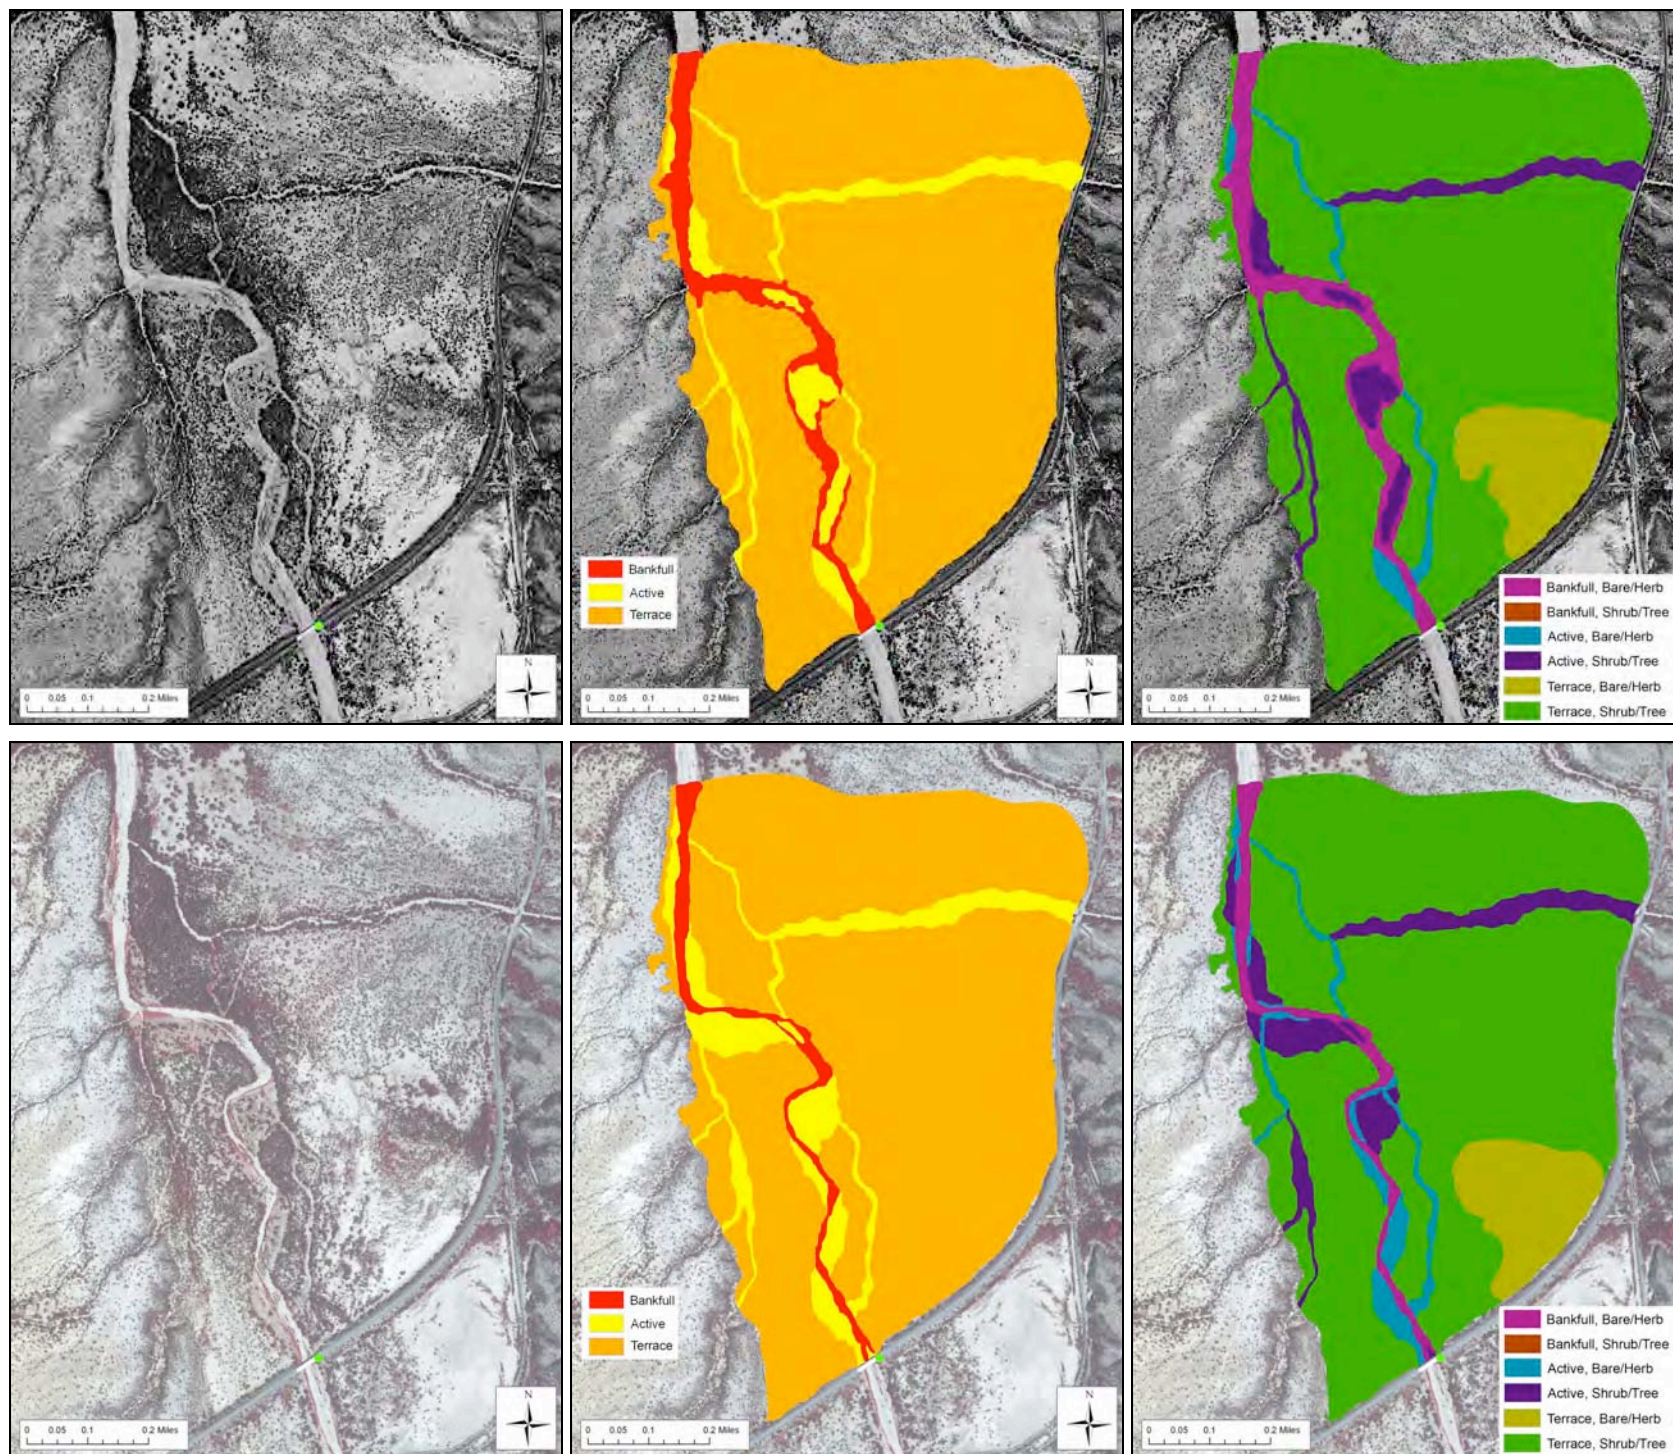
Figure C2. Altar Wash in 1996 (top three) and 2003 (bottom three) showing the change in channel morphology and vegetation.

1996		2003	
	Area (m <sup>2</sup> )	% of Total	Area (m <sup>2</sup> )	% of Total
Bankfull	78,531	5.7	46,273	3.4
Active	108,693	7.8	153,465	11.1
Terrace	1,197,934	86.5	1,177,784	85.5
Total	1,385,158	100	1,377,522	100
Bankfull-Bare/Herb	78,531	5.7	46,273	3.4
Bankfull-Shrub/Tree	0	0	0	0
Active-Bare/Herb	27,862	2.0	57,074	4.1
Active-Shrub/Tree	80,831	5.8	96,390	7.0
Terrace-Bare/Herb	100,612	7.3	101,398	7.4
Terrace-Shrub/Tree	1,097,322	79.2	1,076,386	78.1
Total	1,385,158	99.9	1,377,521	100

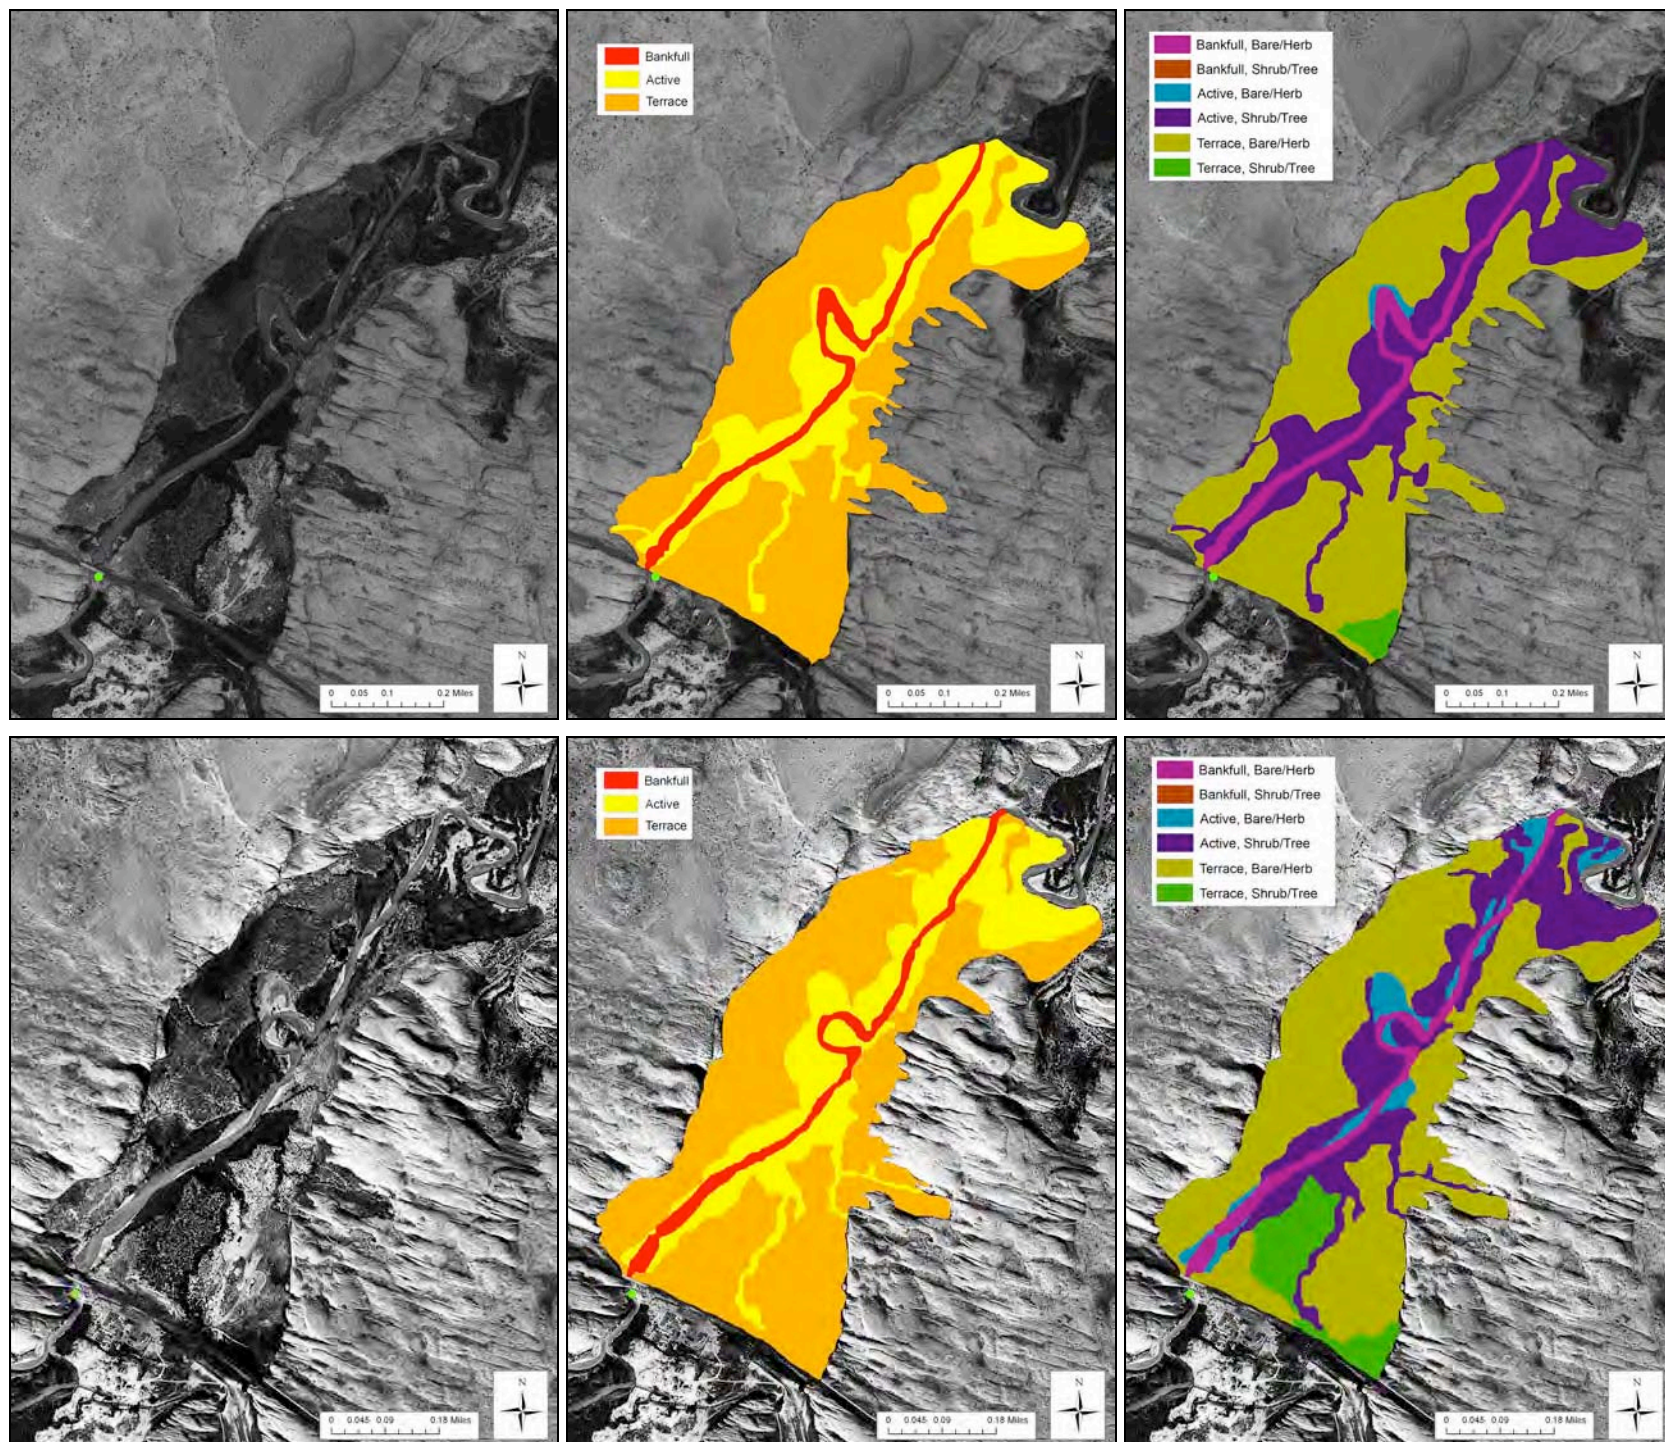
Figure C3. Chinle Creek in 1992 (top three) and 1997 (bottom three) showing the change in channel morphology and vegetation.

1992		1997	
	Area (m <sup>2</sup> )	% of Total	Area (m <sup>2</sup> )	% of Total
Bankfull	50,329	6.4	46,806	5.9
Active	232,373	29.5	233,880	29.4
Terrace	505,251	64.1	513,567	64.7
Total	787,953	100	794,253	100
Bankfull-Bare/Herb	50,329	6.4	46,806	5.9
Bankfull-Shrub/Tree	0	0	0	0
Active-Bare/Herb	4,574	0.6	41,887	5.2
Active-Shrub/Tree	227,798	28.9	191,993	24.2
Terrace-Bare/Herb	491,890	62.4	453,360	57.1
Terrace-Shrub/Tree	13,361	1.7	60,206	7.6
Total	787,952	100	794,252	100

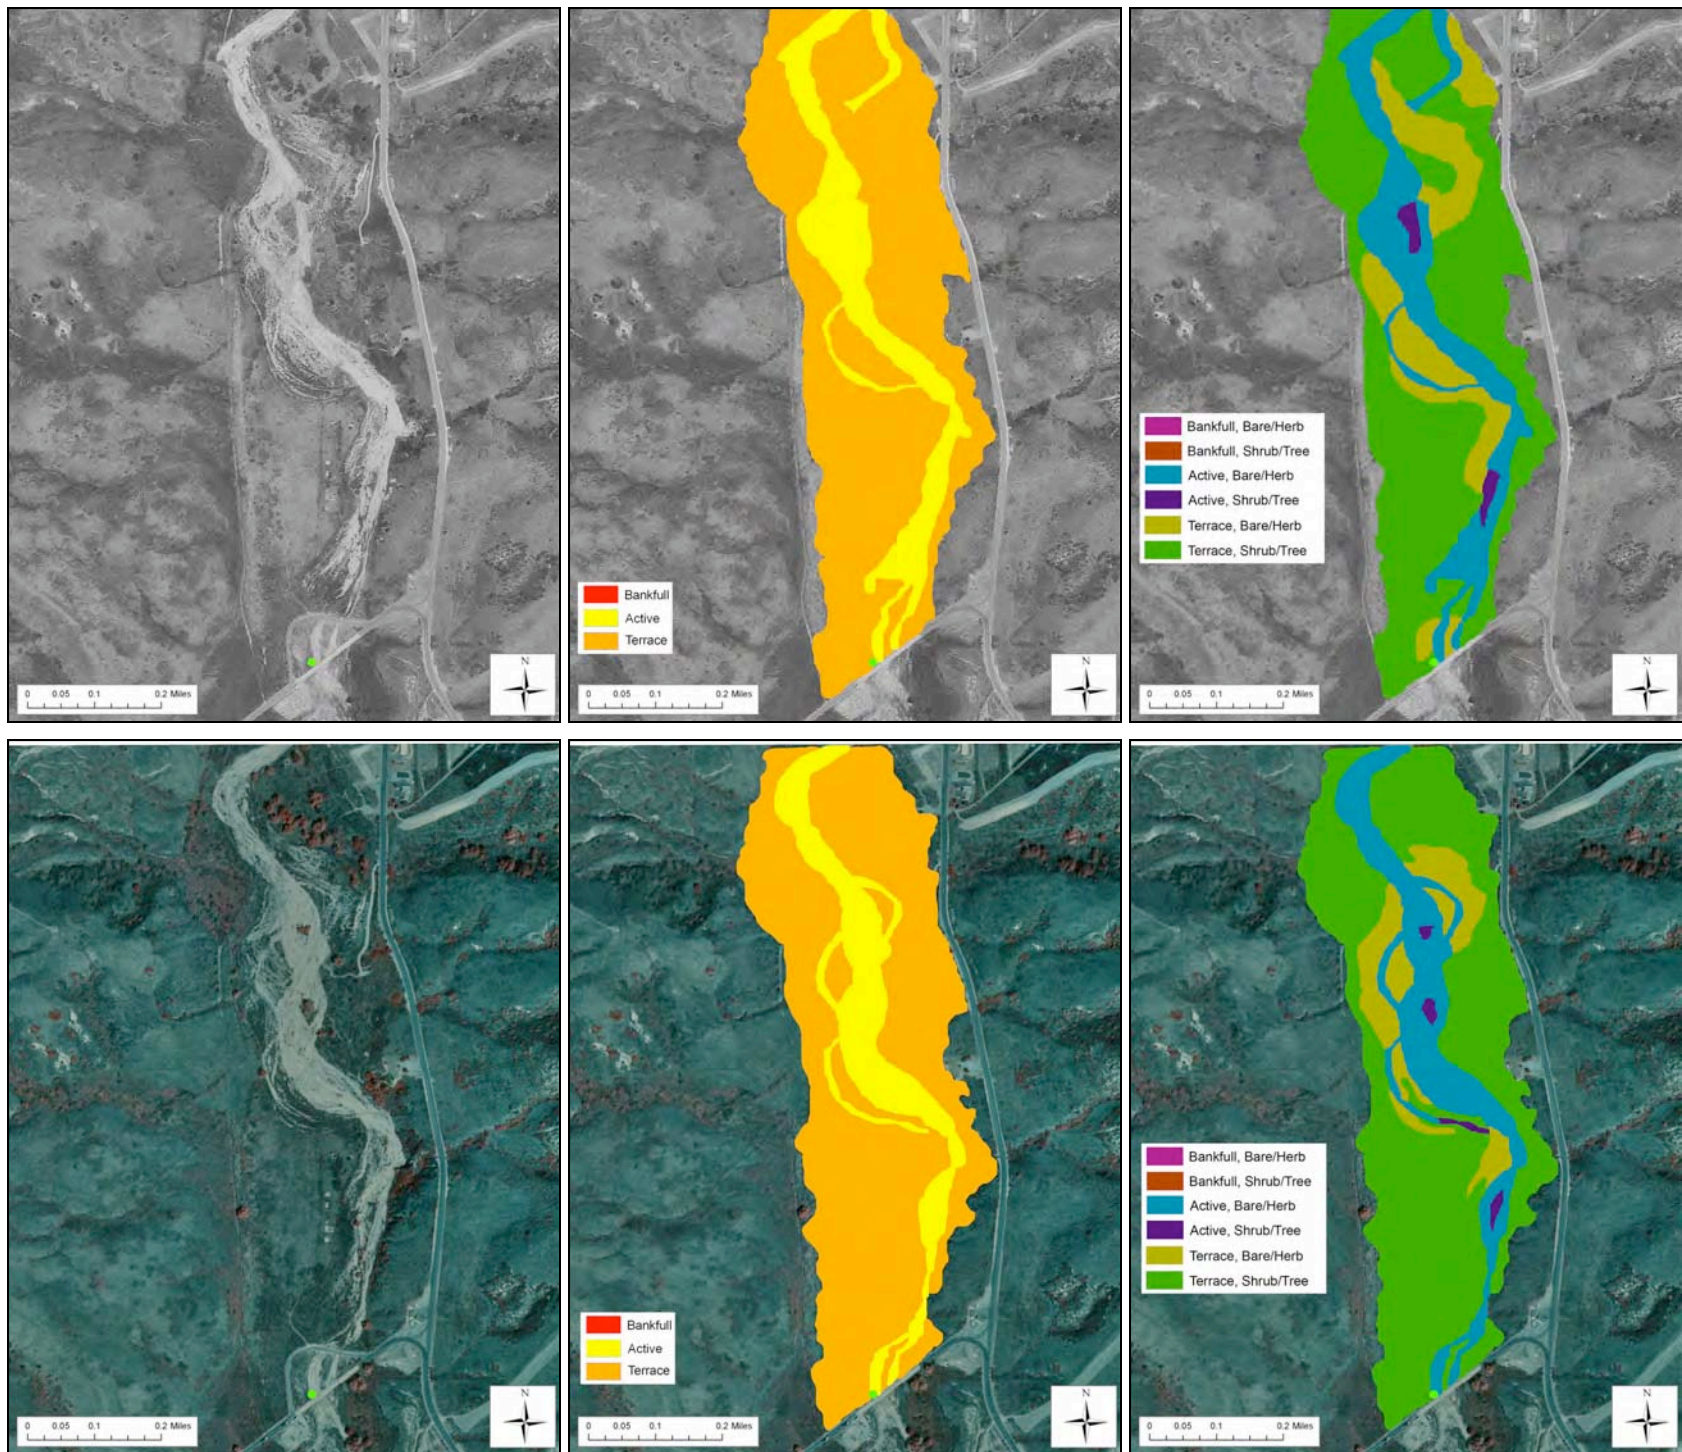
Figure C4. Cristianitos Creek in 1994 (top three) and 1997 (bottom three) showing the change in channel morphology and vegetation.

1994		1997	
	Area (m <sup>2</sup> )	% of Total	Area (m <sup>2</sup> )	% of Total
Bankfull	0	0	0	0
Active	109,841	22.2	104,513	21.3
Terrace	384,010	77.8	385,602	78.7
Total	493,851	100	490,115	100
Bankfull-Bare/Herb	0	0	0	0
Bankfull-Shrub/Tree	0	0	0	0
Active-Bare/Herb	103,763	21.0	99,869	20.4
Active-Shrub/Tree	6,078	1.2	4,644	1.0
Terrace-Bare/Herb	83,897	17.0	55,073	11.0
Terrace-Shrub/Tree	300,112	60.8	330,529	67.4
Total	493,850	100	490,115	99.8

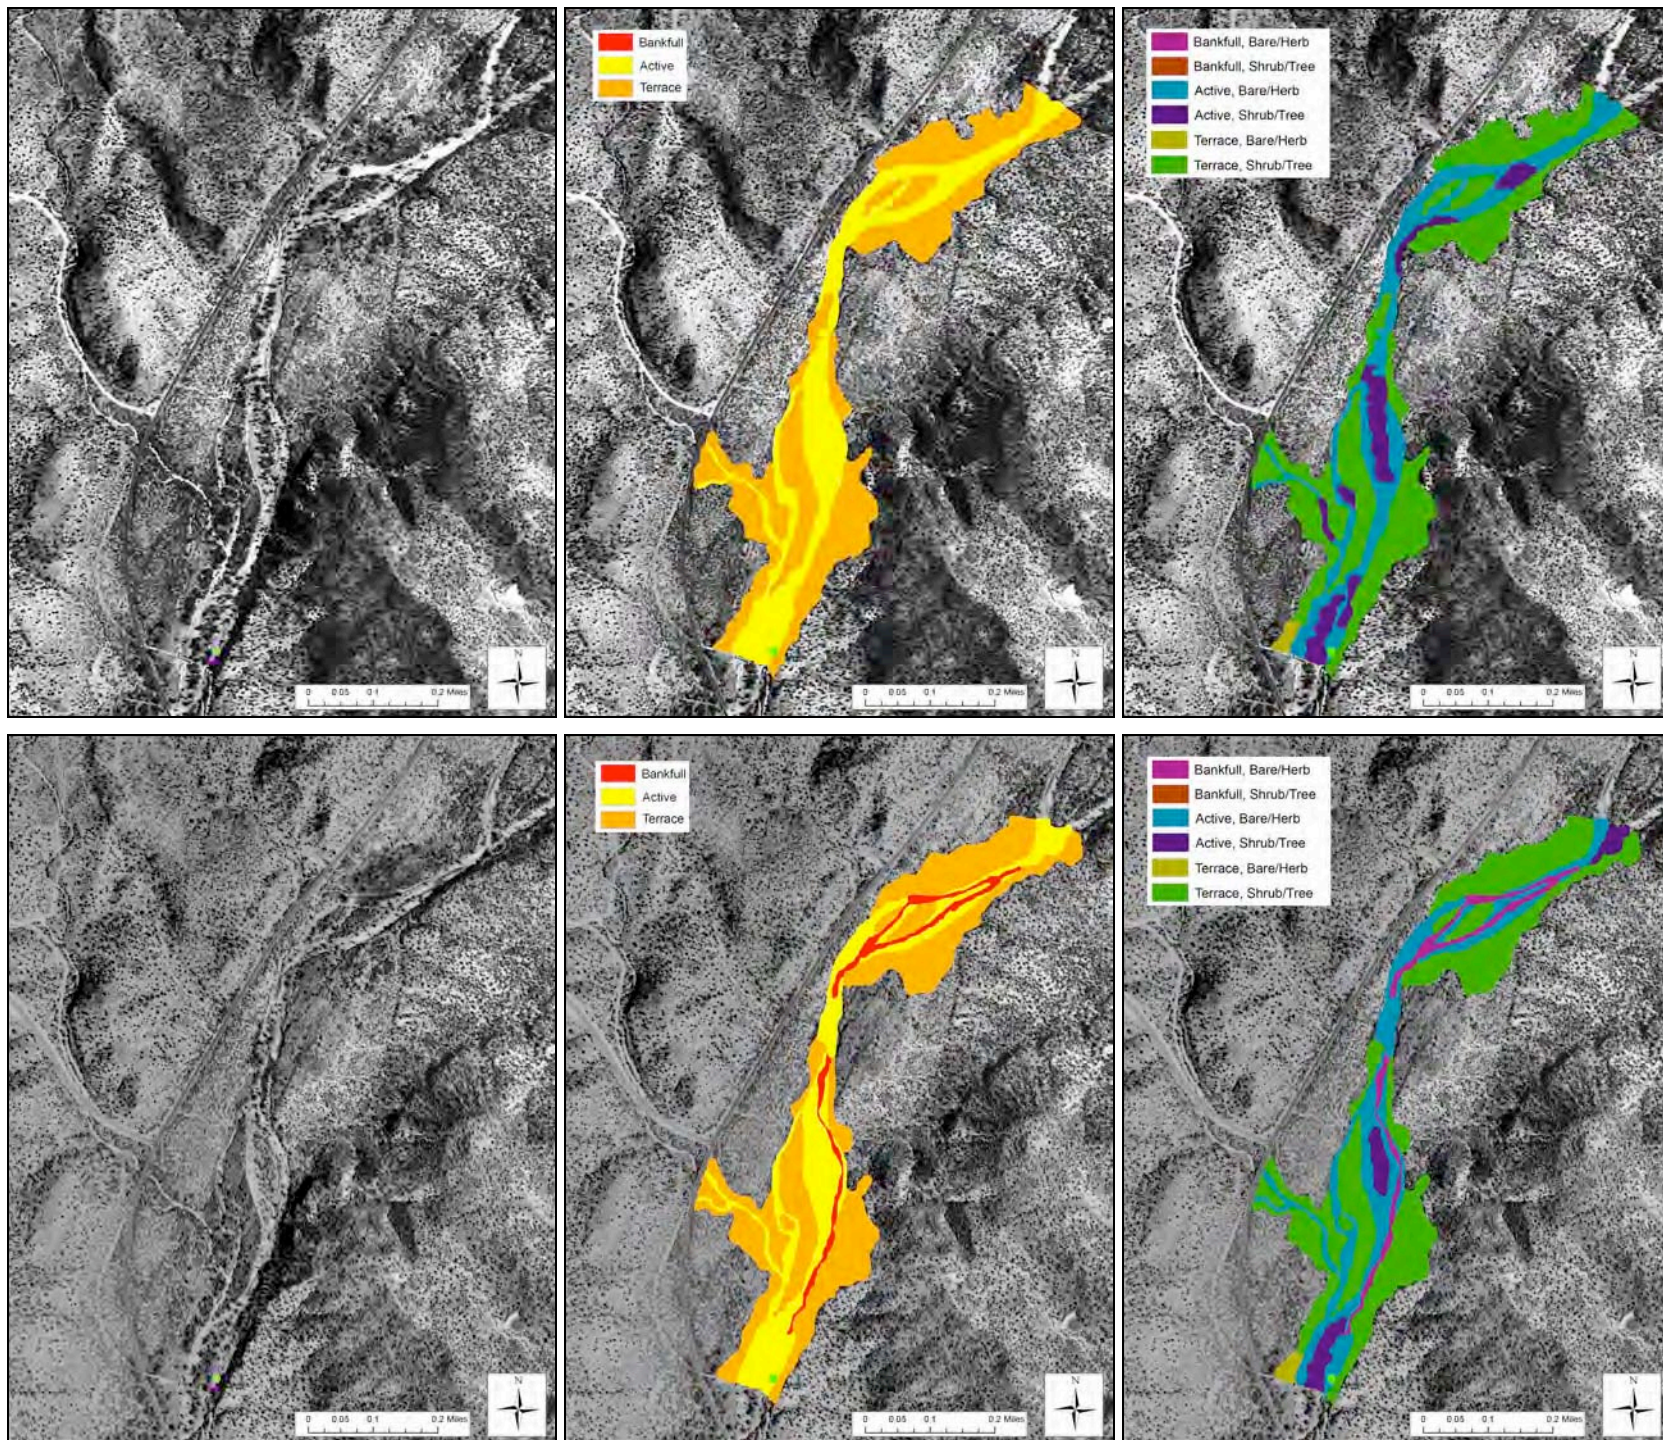
Figure C5. Dry Beaver Creek in 1997 (top three) and 2003 (bottom three) showing the change in channel morphology and vegetation.

1997		2003	
	Area (m <sup>2</sup> )	% of Total	Area (m <sup>2</sup> )	% of Total
Bankfull	0	0	18,938	6.5
Active	114,061	39.5	96,769	33.0
Terrace	174,763	60.5	177,198	60.5
Total	288,824	100	292,905	100
Bankfull-Bare/Herb	0	0	18,938	6.5
Bankfull-Shrub/Tree	0	0	0	0
Active-Bare/Herb	80,973	28.0	79,125	27.0
Active-Shrub/Tree	33,088	11.5	17,644	6.0
Terrace-Bare/Herb	3,006	1.0	3,301	1.1
Terrace-Shrub/Tree	171,756	59.5	173,897	59.4
Total	288,823	100	292,905	100

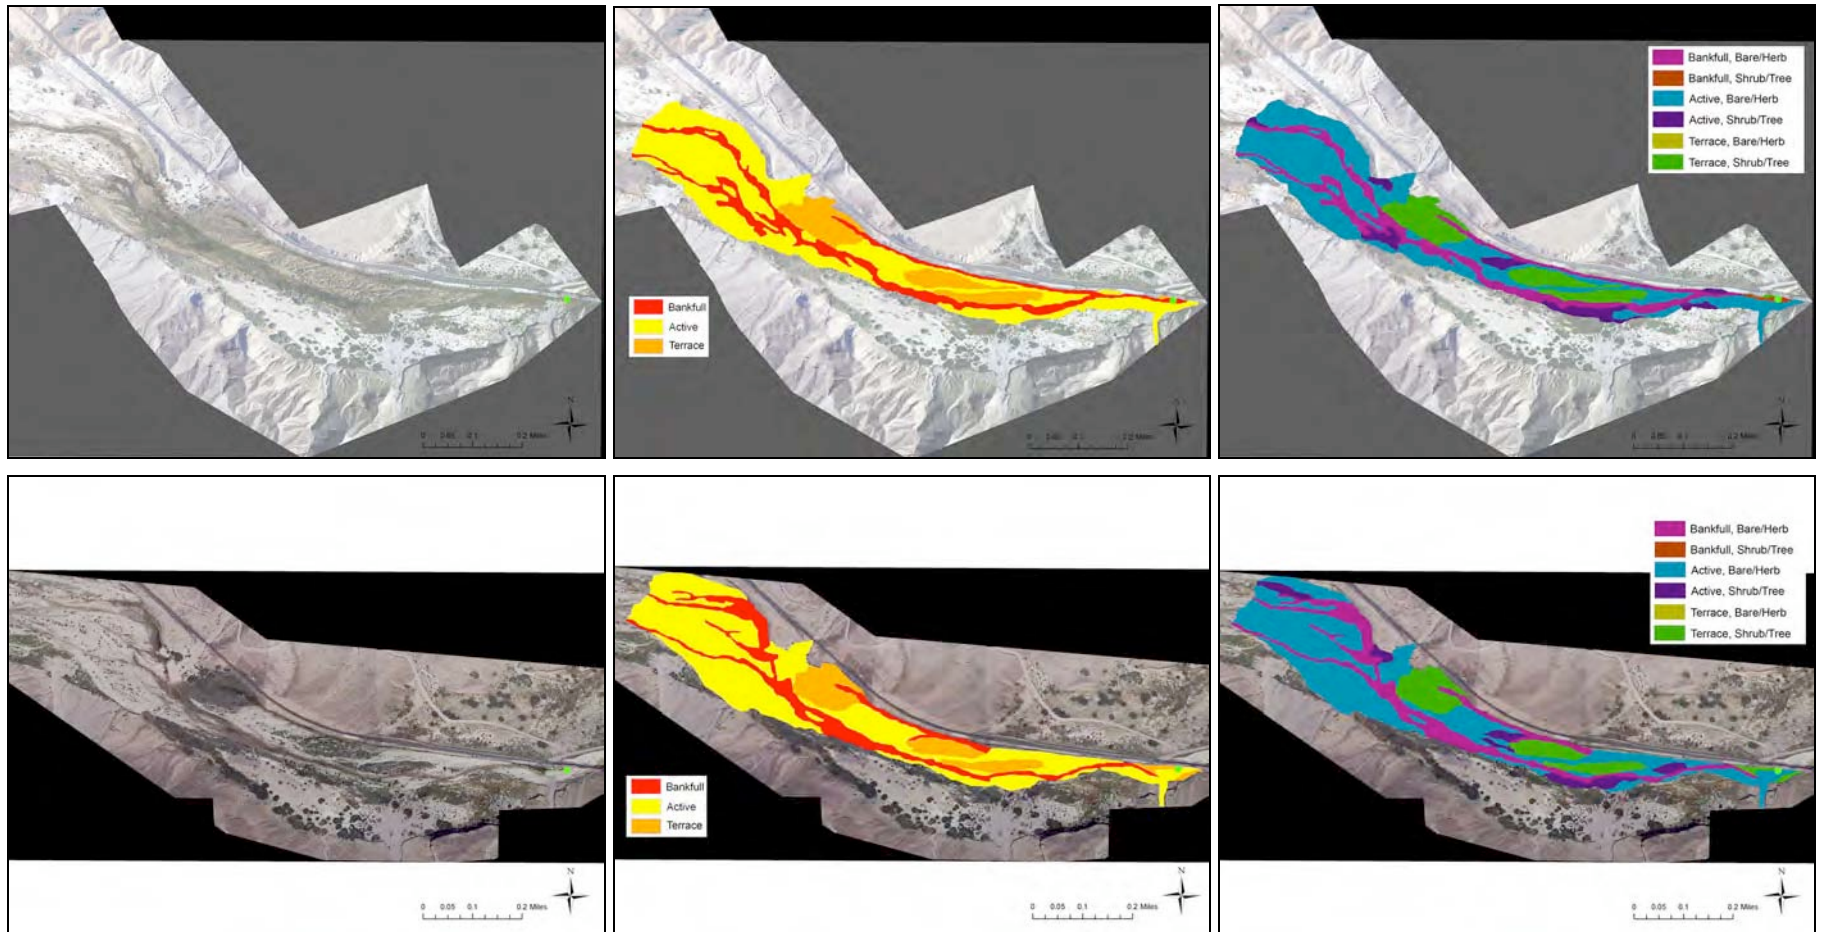
Figure C6. Mojave River in 2003 (top three) and 2005 (bottom three) showing the change in channel morphology and vegetation.

three zones were nearly constant, but the aerial photos show that the bankfull channel was relocated by a low to moderate discharge event. In fact, the bankfull channel at several sites shifted locations and in some cases became small or nonexistent. This supports Lichvar and McColley's (2008) concept that the bankfull channel develops in the final drawdown stages of a geomorphically effective discharge event in the active zone rather than being a separate stable geomorphic unit, so that what is typically called the bankfull zone is actually a low-flow channel within the active floodplain.

2003		2005	
	Area (m <sup>2</sup> )	% of Total	Area (m <sup>2</sup> )	% of Total
Bankfull	52,926	21.5	52,216	21.4
Active	153,097	62.2	154,149	63.3
Terrace	39,979	16.2	37,228	15.3
Total	246,002	99.9	243,593	100
Bankfull-Bare/Herb	51,465	20.9	52,216	21.4
Bankfull-Shrub/Tree	1,461	0.6	0	0
Active-Bare/Herb	134,917	54.8	137,357	56.4
Active-Shrub/Tree	18,180	7.4	16,792	6.9
Terrace-Bare/Herb	0	0	0	0
Terrace-Shrub/Tree	39,979	16.2	37,228	15.3
Total	246,002	99.9	243,593	100
